TECHNOLOGY OVERVIEW

The current case involves a patient with recurrent peroneal tendon dislocation.

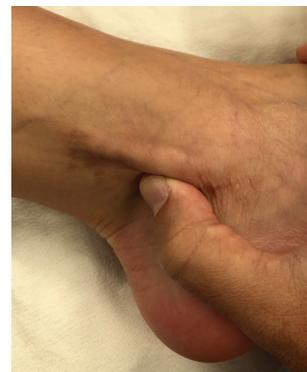
FIGURE 2: Peroneal dislocation with anterior pressure applied to the tendons

Examination under anesthesia revealed gross peroneal tendon dislocation with circumduction and when anterior pressure was applied to the tendons in the retromalleolar region. Intraoperatively, the superior peroneal retinaculum (SPR) was avulsed from its fibula attachment. The SPR was thin and attenuated. Due to its poor tissue quality, an Artelon FlexBand™ was utilized to reconstruct the SPR.

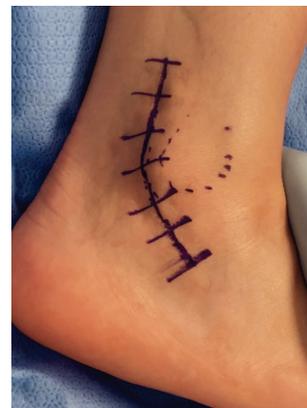
FIGURE 3: Planned surgical incision along course of peroneal tendons

An incision was made in the retromalleolar region over the peroneal tendons and extended distally (Figure 3). The sural nerve was encountered and protected. The SPR was identified and found to be avulsed from its fibula attachment. Its tissue was very thin and attenuated (Figure 4). The SPR was incised and peroneal tendons were identified. No peroneal tear was present (Figure 5). The fibula groove was identified and a revision groove deepening was performed (Figure 6). Finally, the SPR reconstruction was performed. The SPR was repaired back to its fibula attachment with the tendons located (Figure 7). Next, the Artelon Flexband was utilized. A suture anchor was placed into the posterolateral aspect of the fibula at the SPR attachment (Figure 8), and a 0.5 x 8cm FlexBand was attached (Figure 9). A second suture anchor was placed at the calcaneal attachment of the SPR (Figure 10). The unattached end of the Artelon FlexBand was tensioned and secured directly to the lateral calcaneal attachment of the SPR (Figure 11). Incision was closed in a routine manner and the foot was splinted in a neutral position.

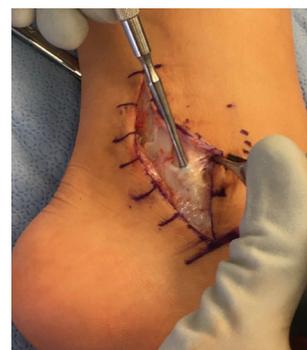
FIGURE 4: Exposure of the SPR. The SPR was avulsed from its fibula attachment and very thin and attenuated

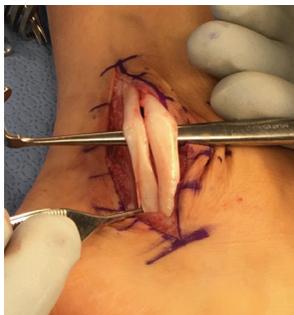
FIGURE 5:
Peroneal tendons were intact without tearing.

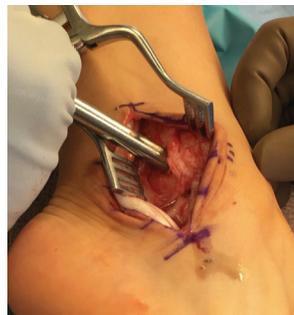
FIGURE 6:
Fibula groove deepening

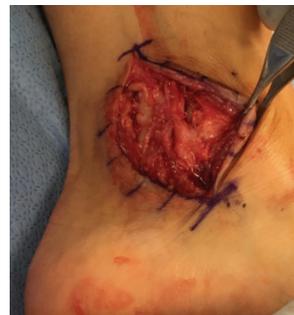
FIGURE 7:
SPR repaired to its fibula attachment

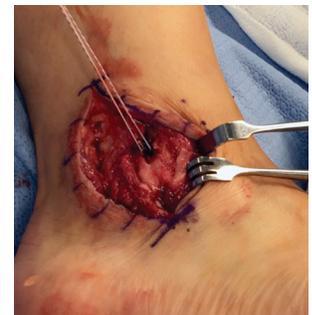
FIGURE 8:
A suture anchor placed into the posterolateral aspect of the fibula at the SPR attachment

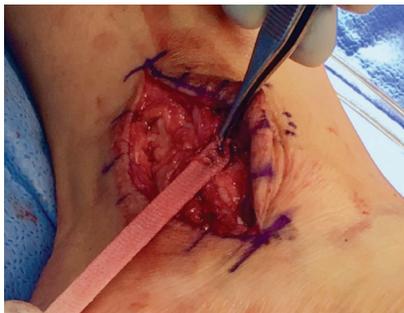
FIGURE 9:
A 0.5 x 8cm FlexBand secured to the fibula

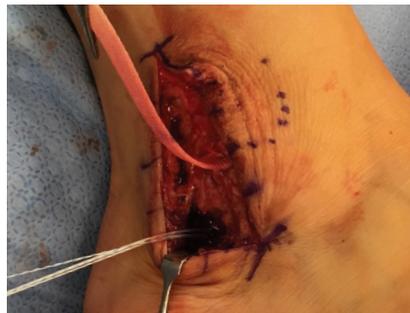
FIGURE 10:
A second suture anchor placed at the calcaneal attachment of the SPR

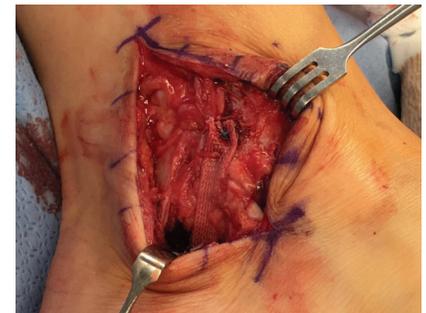
FIGURE 11:
The unattached end of the Artelon FlexBand tensioned and secured directly to the lateral calcaneal attachment of the SPR
