TECHNOLOGY OVERVIEW

The current case involves a patient with a deltoid ligament tear causing ankle pain and medial ankle instability.

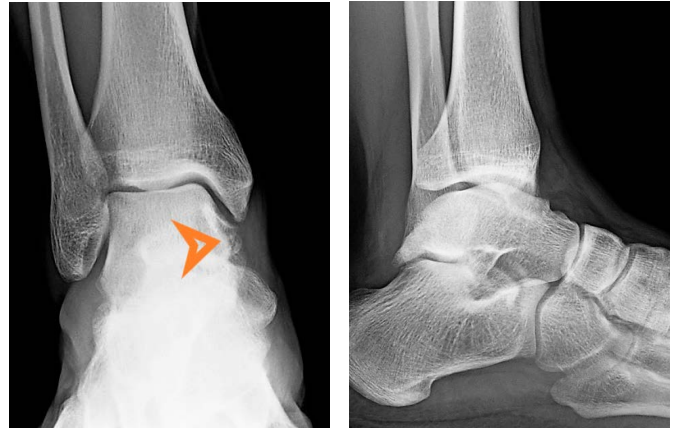
Figures 1&2. Radiographs of the ankle show an avulsion fracture off the talus at the site of the deltoid ligament.

A 30-year-old healthy male presented after twisting his ankle in a basketball game. Clinically he presented with pain and swelling along the medial sides of his ankle. 3 months after failing conservative treatment radiographs showed a small avulsion of the deltoid insertion (Figures 1&2). CT scan confirmed the diagnosis (Figures 3&4).

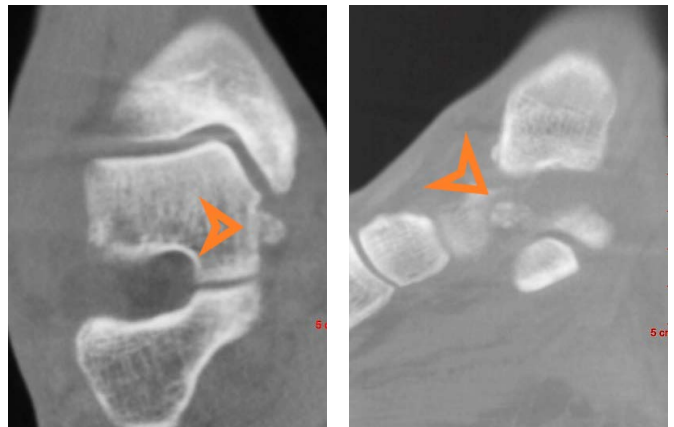
Figures 3&4. CT reconstructions confirm the un-united talar avulsion fracture.

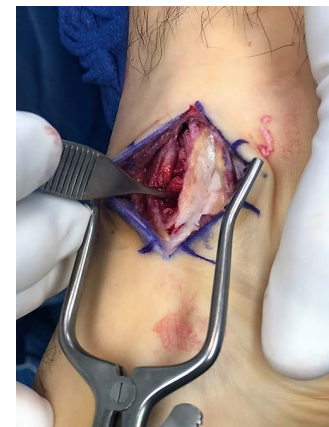
Figure 5. Intraoperative photograph showing torn deltoid ligament and loose avulsion fracture.

The deltoid ligament was found to be thin and incompetent and the ankle unstable. A loose fragment was discovered at the talar insertion point signifying a chronic avulsion fracture non-union. The large defect and degenerated deltoid ligament made primary repair impossible. (Figure 5) Reconstruction & augmentation was necessary and an Artelon FlexBand matrix was determined to be strong enough to sustain the kinematic forces experienced by the deltoid ligament.

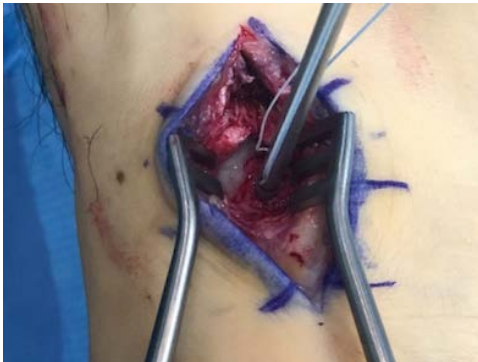
Figure 6. Inserting anchors into the deltoid insertions: talus and medial malleolus

An incision was made along the medial ankle. The medial joint was inspected revealing a torn deltoid ligament. The talar insertion point of the deltoid ligament was isolated and an un-united avulsion fracture removed. An anchor was then placed into the talus (figure 6). The medial malleolus deltoid insertion site was debrided and a second anchor was placed (figure 7). One end of the Artelon FlexBand was secured to the talus. The unattached end of the FlexBand was pulled into 10-20% tension and secured directly to the tibial deltoid insertion point with the second anchor (figure 8-9). The remaining native deltoid ligament was wrapped around the FlexBand (Figure 10), the layers were closed, and a splint was applied (figure 11).

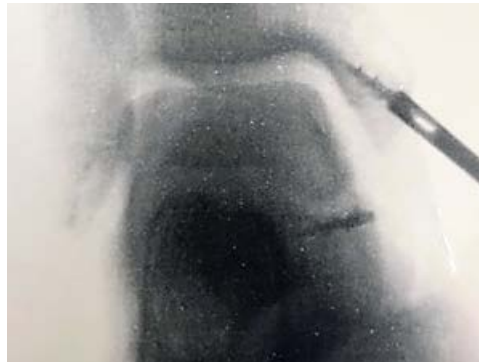
Figure 7. Anchor placements confirmed with fluoroscopy.

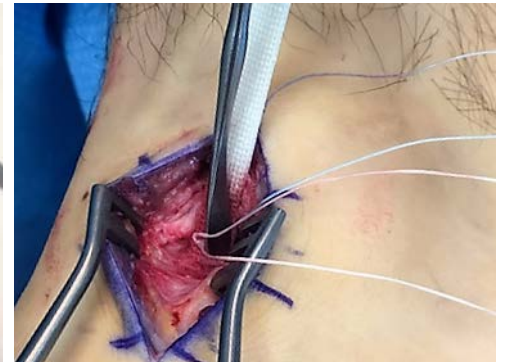
Figure 8. Securing the FlexBand to the talus/deltoid origin

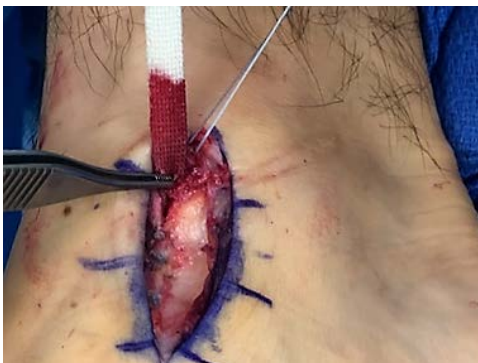
Figure 9. Repair remaining deltoid ligament around the FlexBand matrix then tension and secure to the medial malleolus.

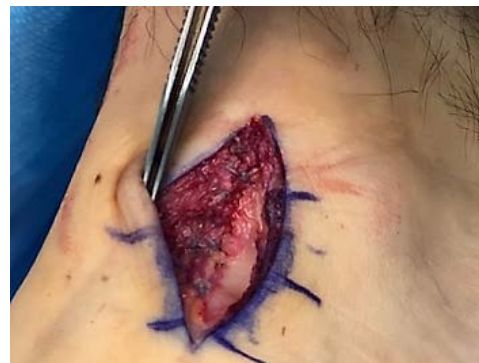
Figure 10. Final repair; deltoid reinforced with FlexBand matrix
